Final Report  
for the Period  
September 1984  
to July 1989

# Pulsed Plasma Mission Endurance Test

Authors:  
R.J. Cassidy

Rocket Research Company  
Olin Defense Systems Group  
11411 Willows Road NE  
Redmond WA 98073-9709

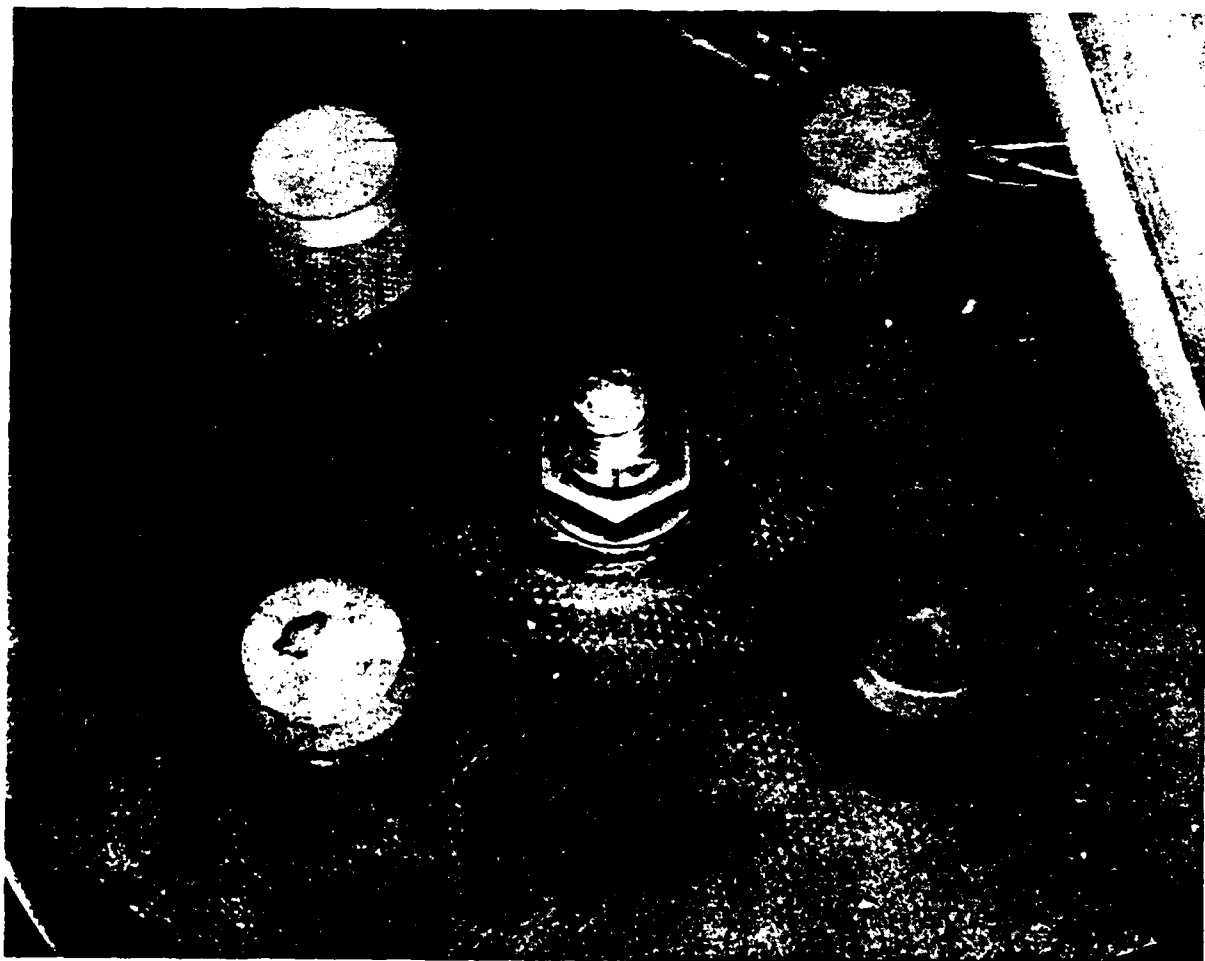
The PPT life test was awarded to RRC after a similar program at McDonnell Douglas Astronautics Company (MDAC) experienced a capacitor failure and was terminated. In the previous program at MDAC, the thruster was damaged and contaminated from the rupture of the capacitor, which released castor oil into the vacuum chamber containing the thruster. RRC, therefore, anticipated some repair and cleaning of the thruster hardware and vacuum chamber. However, further damage of important components, such as the swinging arm thrust stand, was sustained in transit as a result of improper shipping. The GFP items arrived at RRC in a shambles. A complete description of this episode and the ensuing Engineering Change Proposals (ECPs) is given in the section entitled Program Description.

**Fig. 5. Stripline Damage from Capacitor Failure**

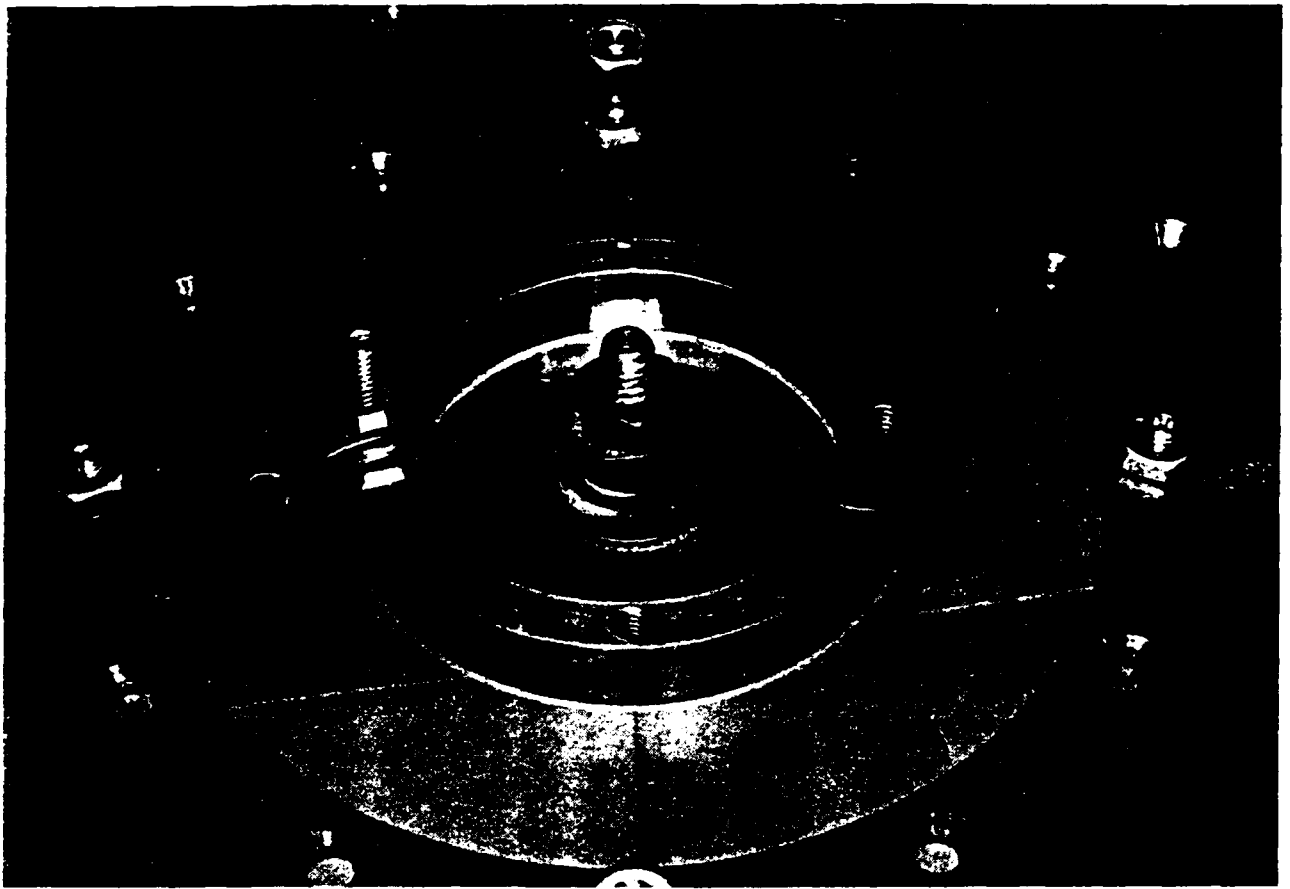
on these surfaces. The black deposit was suspected to be providing a carbon trail on the surface for the arc to discharge across. The insulators were removed and cleaned by sandblasting and then chemically cleaning the surface. The thruster was reassembled and an attempt was again made to get the life test underway. On the first single pulse firing attempt, the same thruster malfunction was observed. Arcing was again visible from within the thruster. The test was halted and the thruster was removed from the chamber. Each time the chamber had to be opened after a wait of several hours to allow the cryo pump to warm up. This resulted in the loss of an entire day even if the failure was detected early in the morning. A complete D&I of the thruster was now felt to be warranted, even though it would be time consuming and difficult.

When the capacitor housing was removed from the thruster, signs of arcing were apparent near the stripline/capacitor interface. Removal of the stripline revealed a heavy coating of black carbonaceous deposit on the surface of the capacitor insulator. Figure 9 shows the extent of the arcing and the deposit which was formed. This deposit was the source of the high resistance short which was preventing full charging of the capacitor bank. Further examination of the capacitor was made to determine what caused the arcing to occur. The most likely scenario involved the center mounting post adapter. The mounting post adapters were fabricated by RRC after the Sandia capacitors arrived with no center posts. The Sandia capacitor design varied from the Maxwell capacitor design in this regard, which meant that the Sandia capacitors would not interface with the stripline. Figure 10 illustrates the difference between the Maxwell and the Sandia capacitor electrode configurations. Apparently, no specification was included in the Sandia contract with AFAL documenting how the center post should be configured. RRC was faced with the problem of making the capacitors work with the existing stripline and decided upon the simple adapter design shown in Figure 11. This seemed to be an adequate solution, provided two nuts were used to clamp the stripline securely to the center post adapter. In the case of the arcing which occurred at the center post, what had apparently happened was that the lower nut, underneath the stripline, had dropped off the bottom of the 1/4-20 threaded portion of center post adapter, thus breaking the surface contact with the stripline and resulting in an arc.

Fig. 9. Arc Damage and Carbon Deposit

This assessment of the incident led RRC to redesign the center post adapter with a mounting shoulder to make contact with the stripline, and with improved contact to the Sandia capacitor center electrode. The revised mounting adapter design is shown in Figure 12. These adapters were fabricated and installed on four of the Sandia capacitors, including the one which had a coating deposited by the arc from the earlier testing. This capacitor had been thoroughly cleaned to remove all visible traces of the deposit. The thruster was reassembled and prepared for another attempt at the start of the test. The next try occurred on August 22, 1986. The chamber was evacuated to  $10^{-5}$  torr backpressure. Upon giving the single shot command to the thruster, internal arcing was observed and the thruster did not fire. No further shots were attempted. The chamber was vented and the thruster was removed for inspection. Inspection revealed arcing had occurred on the same capacitor as the previous incident. As before, a thick black coating covered the top of the capacitor. Close examination revealed that the stripline was deformed into a slight upward bow. Two probable causes were identified for the arcing problems. The first was that stripline deformation dating back to the MDAC capacitor explosion was resulting in poor surface contact with the capacitor. The second was that the capacitor insulator was not capable of holding off the voltage, possibly due to damage incurred during the earlier arcing.

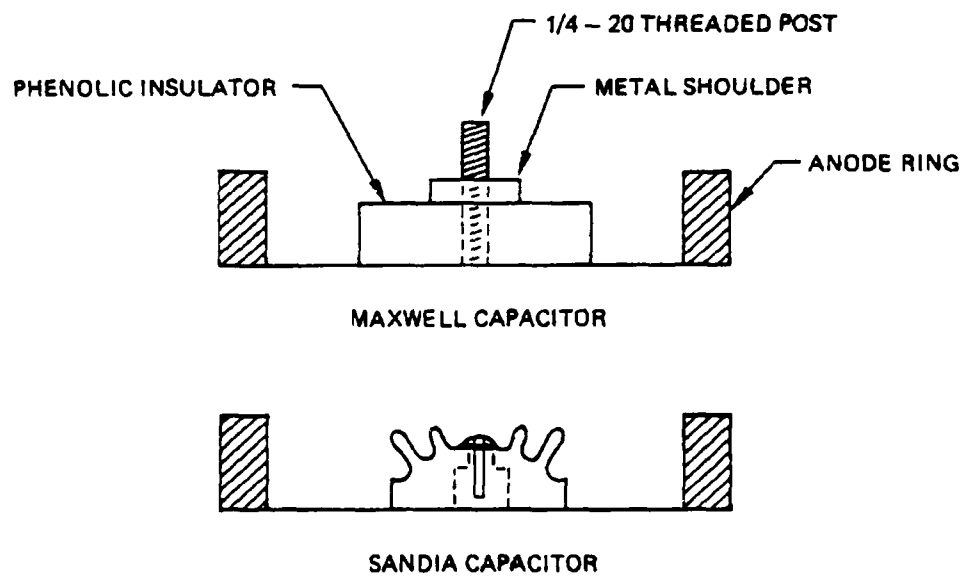
Fig. 10. Capacitor Center Electrode Comparison

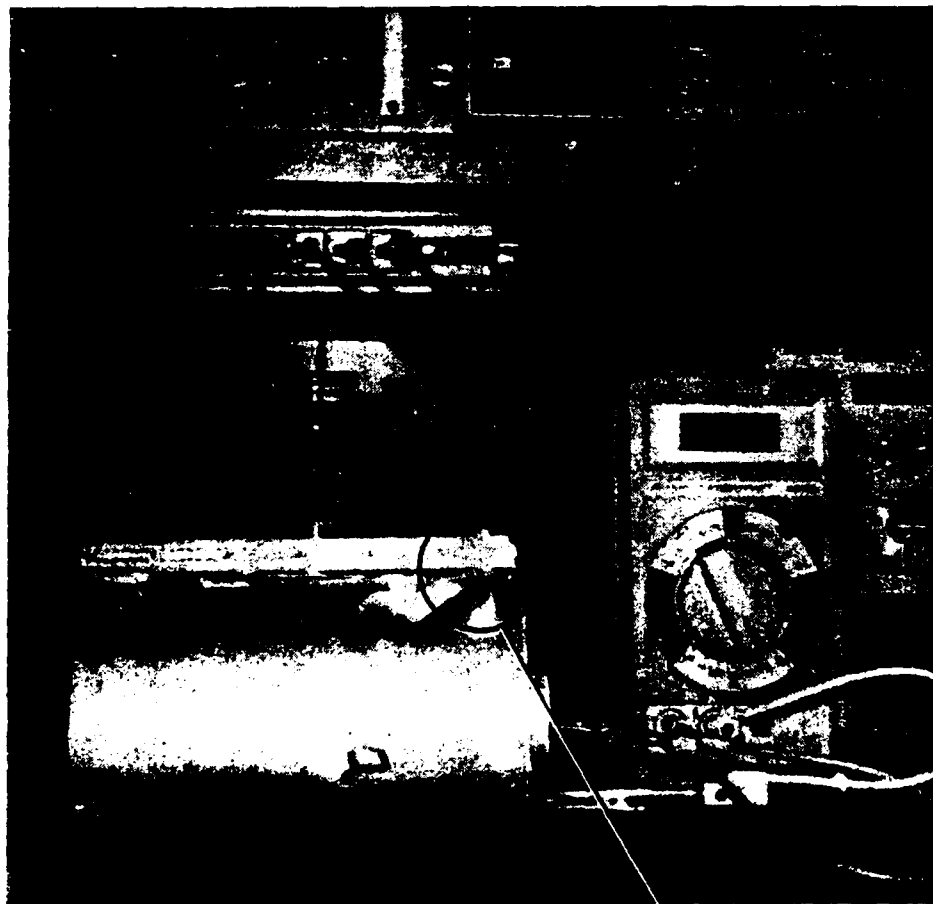
by a periodic rezeroing of the signal, while attempts were made to adjust the amplifier gain. The test continued in automated mode for approximately four hours. At approximately 2:40 p.m., a failure of the number 2 capacitor occurred. The ground test console sensed the capacitor failure as a short in the load and switched to thruster malfunction mode. RRC personnel discovered the test was stopped and determined the cause to be inside the vacuum chamber. The chamber was vented and subsequent investigation revealed that the capacitor bank was reading a dead short on an ohmmeter. The thruster was then removed from the chamber and disassembled to allow inspection of the capacitor bank. This inspection found the number 2 capacitor had failed by shorting internally. The capacitor case was intact, but bulged out near the top flange, very close to the fill tube. Figure 15 shows the post-test condition of the capacitor.

NOTE: BULGE IN CASE

**Fig. 15. Capacitor SC 320 PC 014 Condition After Failure**

After the capacitor failure, the thruster was repaired by replacing the failed capacitor, and the thruster was prepared again to restart the life test. Confidence was now high that the problems which had prevented the conduct of the test were solved. The test was restarted on November 10, 1987. Although the thruster was firing correctly in automated mode most
